# Hydrogeologic Analysis of the Water Supply for Bancroft, Caribou County, Idaho

Information Circular 61  
ISBN 1-55765-115-9  
2005

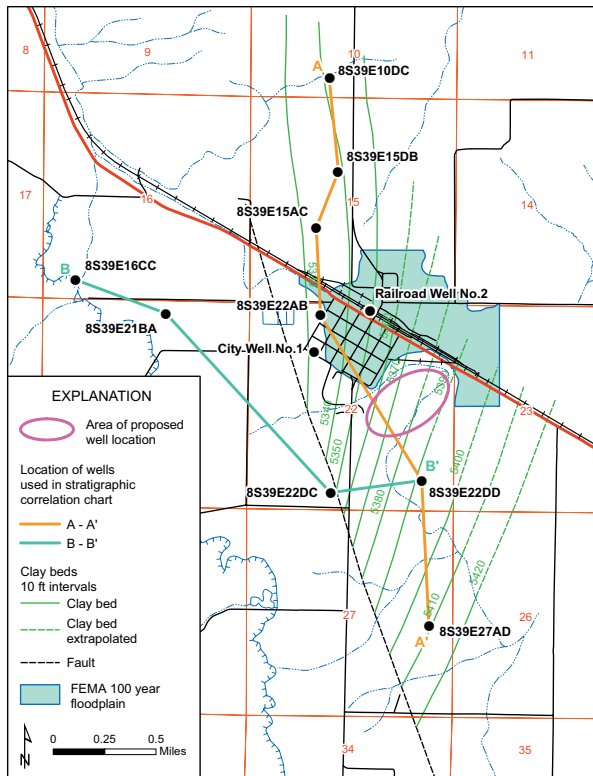
Figure 2. Underlying clay bed, location of wells used in the stratigraphic correlation chart, and proposed well location for Bancroft.

Well logs reveal a confining layer of clay-rich sediment that may protect the aquifer underneath Bancroft.

Figure 3 correlates the geologic units identified in these wells. Section lines A-A' and B-B' shown in Figure 2 indicate the locations used in Figure 3. Figure 3 shows the correlation of the clay-rich confining layer between the wells, and Figure 2 shows the geographic extent of this bed. Since City Well No. 1 and Railroad Well No. 2 lack adequate data, we omitted these wells from the correlation analysis. These wells lie between wells 8S39E22BA and 8S39E22DD. A correlation of the clay bed between the latter two wells implies that City Well No. 1 should penetrate the bottom of the clay layer approximately 107 feet below ground surface. Railroad Well No. 2 should intercept it approximately 108 feet below ground surface. The clay layer probably protects surface contamination from infiltrating into the underlying basalt aquifer.

The presence of fecal coliform and elevated nitrate concentrations pose problems to the long-term viability of the existing wells. Figures 2 and 3 show that Bancroft is above a clay-rich confining layer interbedded between basalt flows. This layer probably reduces vertical movement of any locally contaminated water, protecting the underlying ground water by forcing contaminants to migrate horizontally. Poor construction of the two town wells likely explains how contaminants enter the Bancroft water supply system.

We recommend the town drill south of town within the area of the new park (Figure 2). The clay-rich confining layer overlying the aquifer will provide protection from contamination if the town adopts proper well construction techniques. A high-solids bentonite grout or hydrated bentonite chips and pellets will provide the best seal and prevent ground-water contamination (Christman and others, 2002). The sealant must reach a depth below the confining layer to prevent contamination. In the recommended target area, the projected depth onto line A-A' (Figure 2 and 3) to the bottom of the clay-rich confining layer is 68 feet. The specific depth, however, should be determined by the depth to the clay layer when drilled.

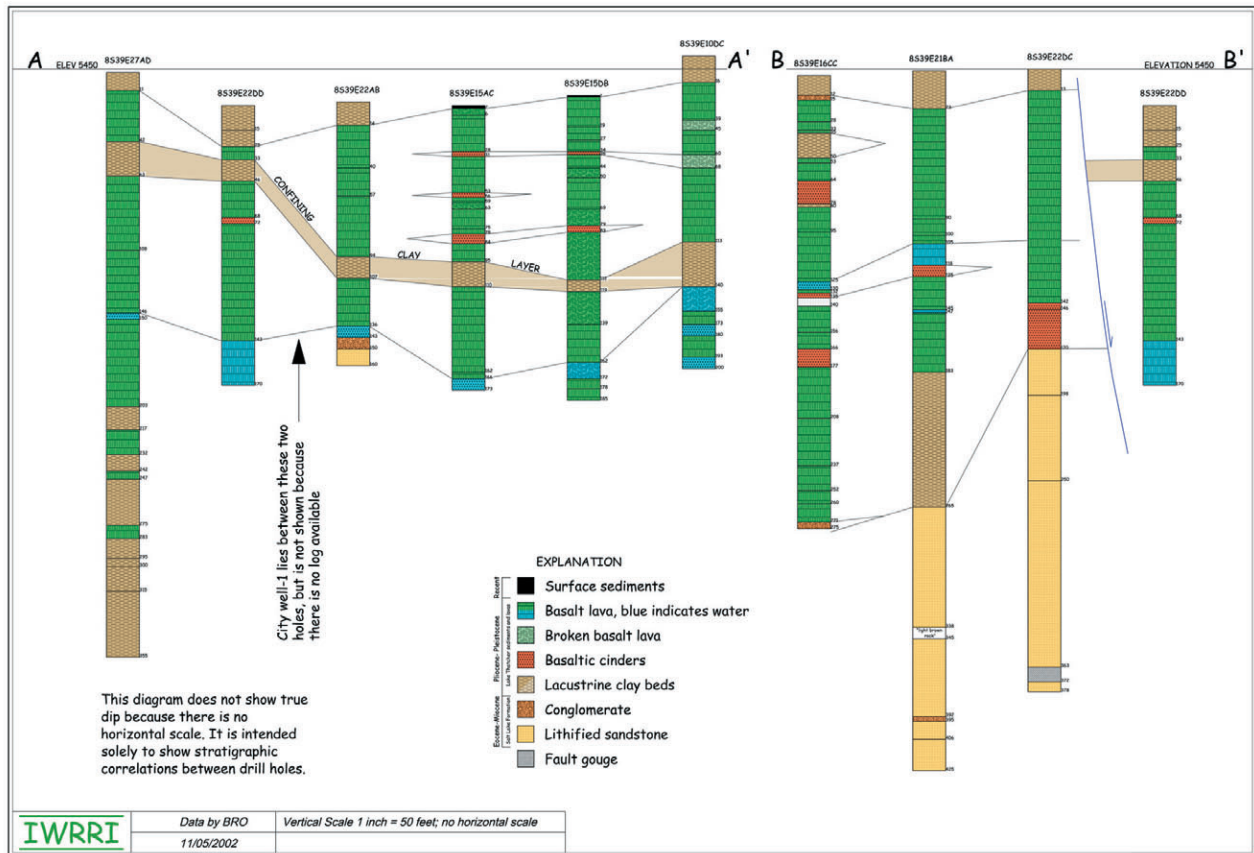
Figure 3. Diagram showing stratigraphic correlations between drill holes along lines A-A' and B-B' in Figure 2.

Projecting the 97-foot static water level along line A-A' (Figure 3) suggests the aquifer is confined. No wells along A-A' show a static water level above the clay layer. This shows that the aquifer is unconfined but may become confined during periods of increased recharge. In addition, no well logs indicate an aquifer above the clay bed.

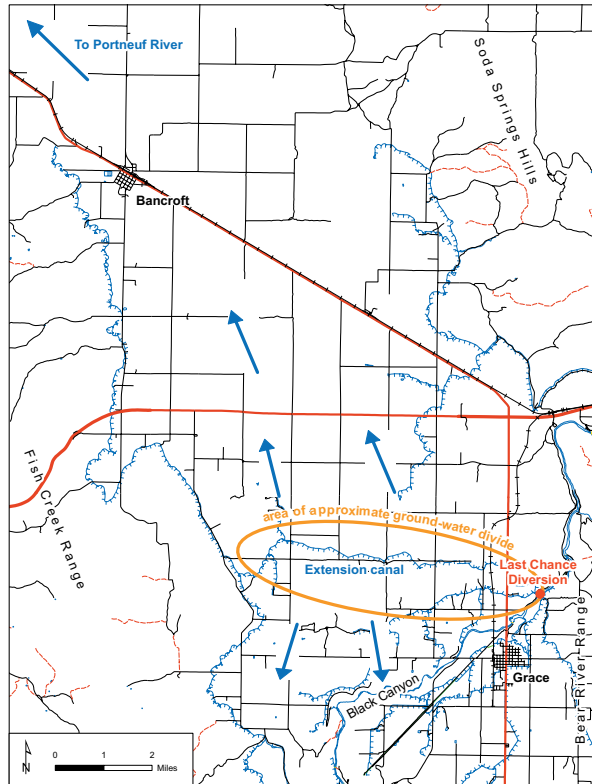
Norton (1981) indicates that a ground-water divide, located near the Last Chance Diversion and the Extension Canal, separates Gem Valley into two flow systems (Figure 4). A northwesterly ground-water flow system discharges to the Portneuf River northwest of Bancroft, while a southerly flow system discharges to the Bear River through springs in Black Canyon. Leakage from the Last Chance diversion and Extension canal serve as the primary source of recharge into both systems. Leak-

Figure 4. Ground-water flow direction and divide for Gem Valley.

Bancroft lies north of the divide where ground water flows to the northwest and discharges to the Portneuf River (Figure 4). Potentiometric contours of water in the basalt aquifer, derived from well log data, demonstrate that water flows north towards the Portneuf River. This supports Norton's (1981) interpretation of a northwestern ground-water flow direction (Figure 5). Leakage from the West Branch, Soda, and Extension canals and the infiltration of precipitation recharges the aquifer in northern Gem Valley. Additional recharge comes from irrigation water unused by vegetation.

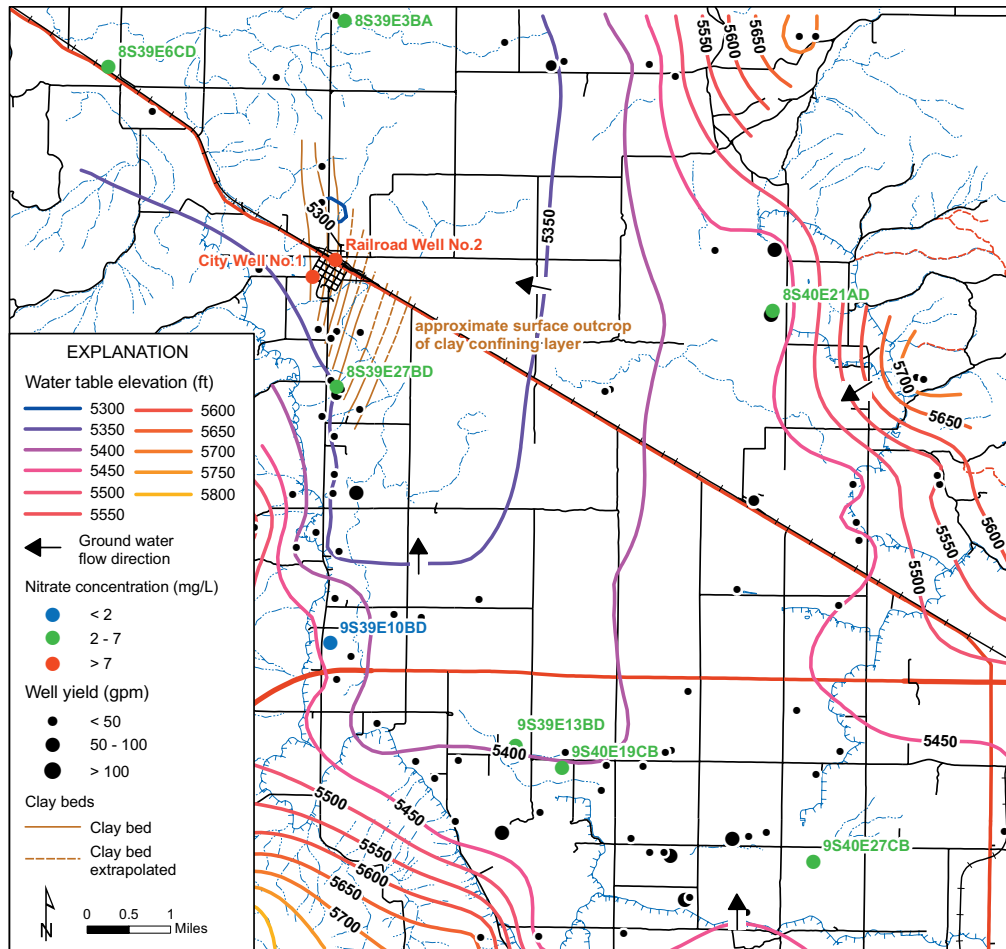
The USGS provides data on water quality and static water levels for wells in Gem Valley. Elevated nitrate levels occur throughout the aquifer. Both City Well No. 1 and Railroad Well No. 2 measure close to the maximum contaminant level (MCL) of 10 mg/L and have higher concentrations than surrounding wells in the northern half of Gem Valley. Figure 5 shows locations of the USGS monitoring wells, the Bancroft wells, and the most recent nitrate concentrations. According to water-table contours, the USGS wells are located upgradient

Figure 5. Water table, ground-water flow direction, and most recent nitrate concentrations in the Gem Valley area.

contaminants could travel down poorly sealed wells through the clay layer and pollute the basalt aquifer. The agricultural business southeast of town is another potential source of contamination not mentioned in the source water assessment report. Nitrate from this possible source would likely follow the flow path described above. The part of town northeast of the railroad uses septic tanks rather than the municipal sewer system. These septic tanks lie upgradient and may play a role in the nitrate contamination observed in the municipal wells. Contaminants residing southeast of the surface exposure of the clay beds pose concern because they may flow beneath the clay toward the proposed well (Figure 5). These sources include State Highways 30 and 30N, railroads, and agricultural lands.

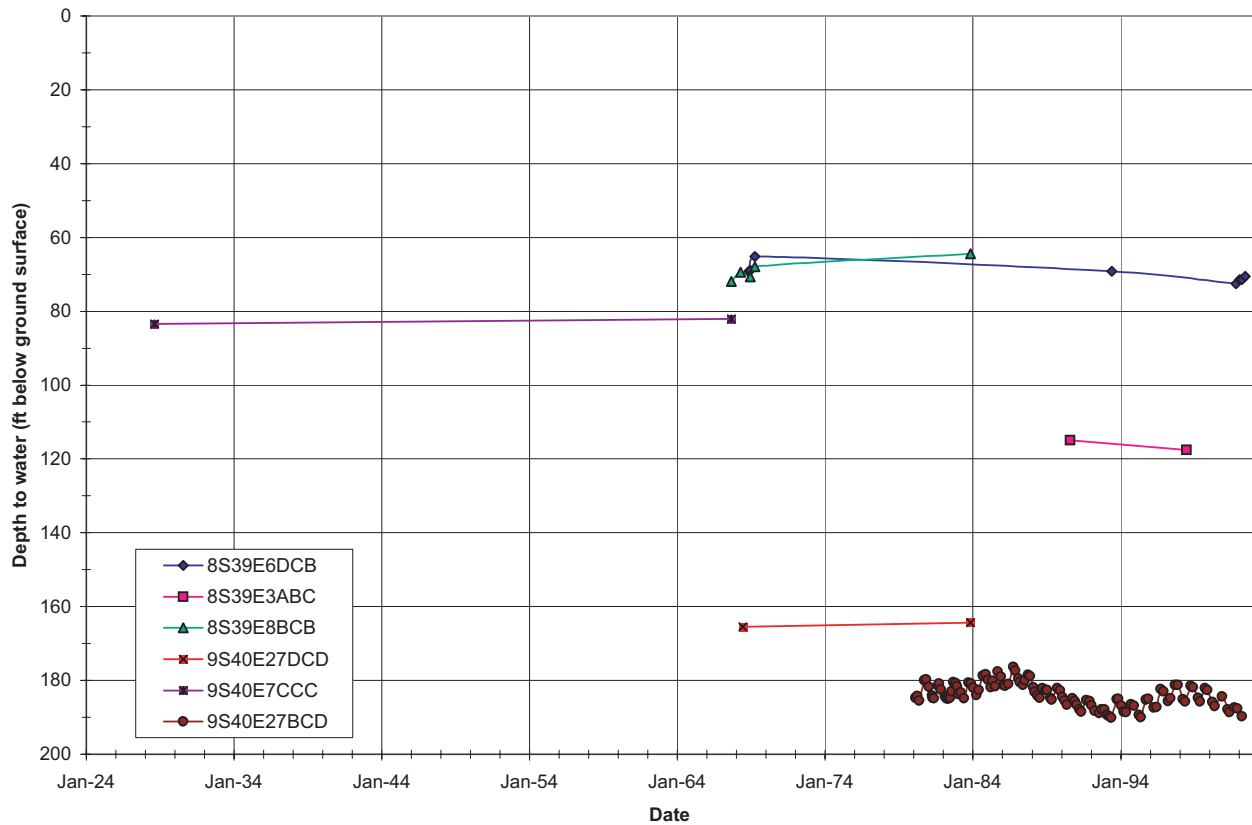
Although the two supply wells lack sufficient data for analyzing the aquifer, the Idaho Department of Water Resources (IDWR) and the USGS provide static water levels for other nearby wells in the northern half of Gem Valley. Several wells monitored by the USGS indicate that water levels have remained constant over the past 74 years, thus providing evidence of adequate recharge for a sustained water supply (Figure 6). In addition to adequate recharge, well yields within the basalt aquifer, obtained from IDWR well logs, range from 20 gallons per minute (gpm) for individual domestic use to greater than 1,000 gpm for irrigation use (IDWR records; Figure 5). City Well No. 1 and Railroad Well No. 2 currently yield an adequate volume of water for Bancroft. These data provide evidence that a properly constructed well in the basalt aquifer can supply sufficient water to Bancroft.

Figure 6. Ground-water levels for USGS monitoring wells within the Gem Valley area <<http://idaho.usgs.gov/>>.

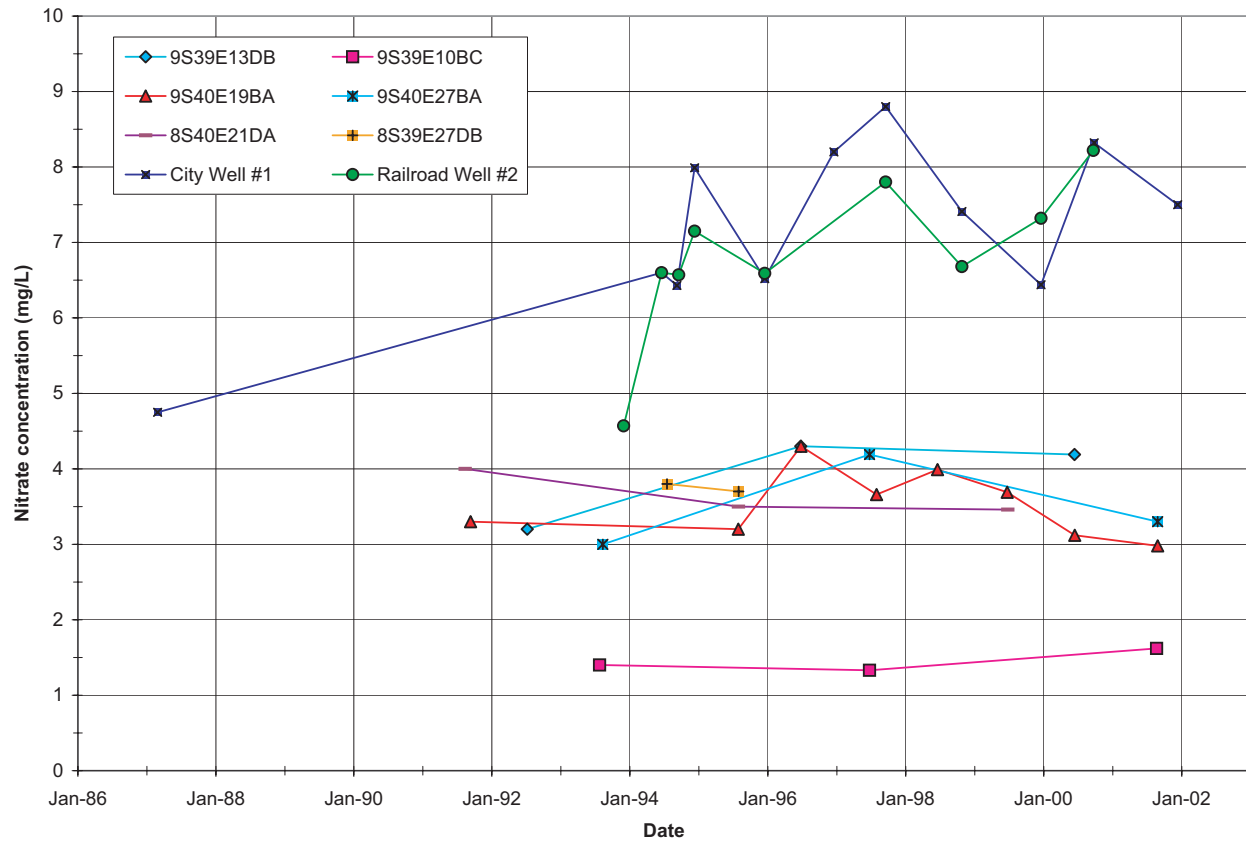
from City Well No. 1 and Railroad Well No. 2, and water flows toward the Bancroft wells. An analysis comparing USGS monitoring wells with those at Bancroft suggests the problem is well construction rather than nitrate contamination in the entire aquifer (Figure 7). Figure 7 suggests that both wells originally contained nitrate concentrations around the elevated background values of the aquifer. In recent years, however, nitrate concentrations increased in the town's wells, while other wells remained relatively constant.

Figure 7. Nitrate concentrations for the Bancroft supply wells and USGS monitored wells <<http://idaho.usgs.gov/>>.

The town should abandon the current supply wells following proper abandonment procedures. Proper abandonment is essential for minimizing on-going surface contamination to the aquifer via poorly constructed wells.

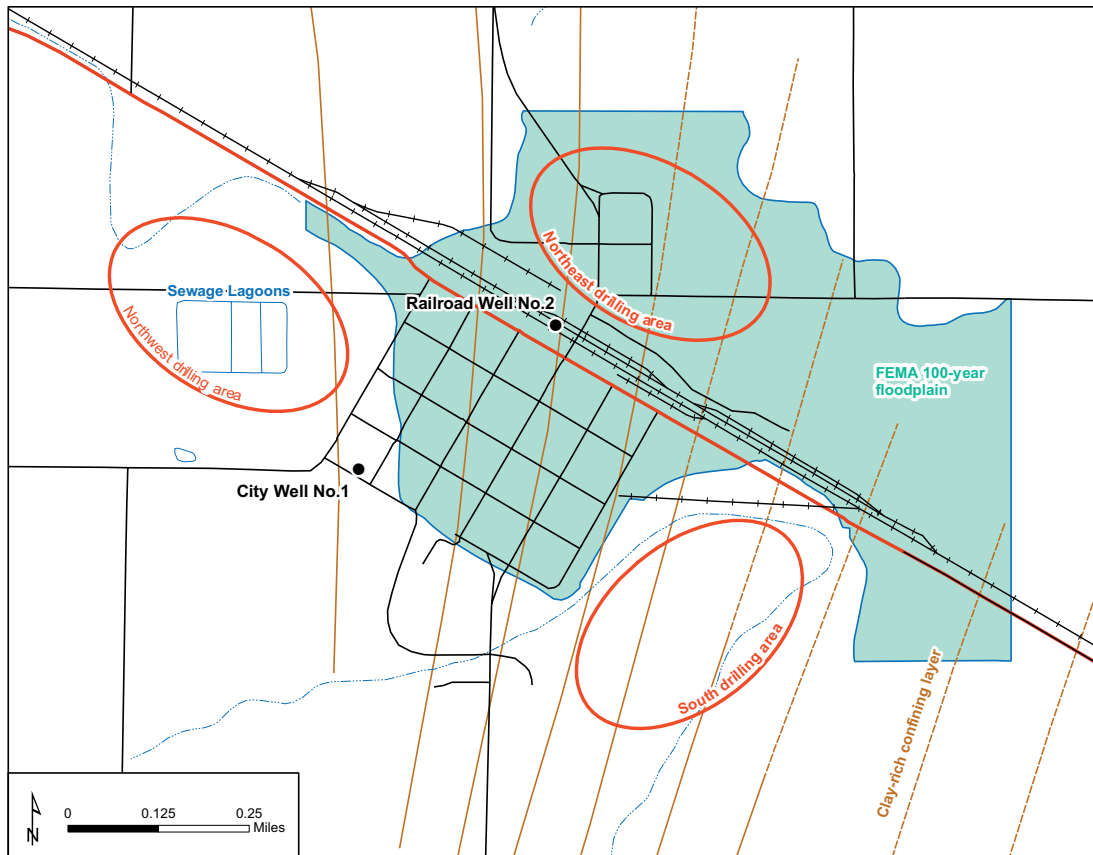
We partitioned the Bancroft region into three potential areas for ground-water development to determine the best location for water from the only viable aquifer. These sites are northwest of town, northeast of the railroad, and south of town (Figure 8).

Contamination from the town that leaks through the confining clay layer, or leakage from sewage lagoons, may impact the quality of water in the aquifer northwest of town. These factors make this a high risk area for maintaining water quality. The extent of the clay-rich confining bed to the northwest is also unknown because of the lack of well data.

A well located northeast of town may encounter several problems. This unincorporated part of town lacks central water or sewage lines, and residents there use septic tanks. Drain fields from the septic tanks may leach contaminants that could enter the aquifer. Most of the area is within the FEMA 100-year floodplain. Locations within the floodplain are more susceptible to contamination by surface water. The cost of constructing a pipeline under the railroad grade and Idaho highway 30N may be a major drawback.

There are several advantages to this area. Any contamination generated in town will have minimal influence because of the northwestward ground-water flow direction. The new well location is outside of the FEMA 100-year floodplain, reducing the impact of contamination from surface events. The town already owns and plans to develop a park in this area, so there is no cost associated with purchasing the land.

Figure 8. Three potential drilling areas for Bancroft.
